SSC-337

SHIP FRACTURE MECHANISMS INVESTIGATION

SHIP STRUCTURE COMMITTEE

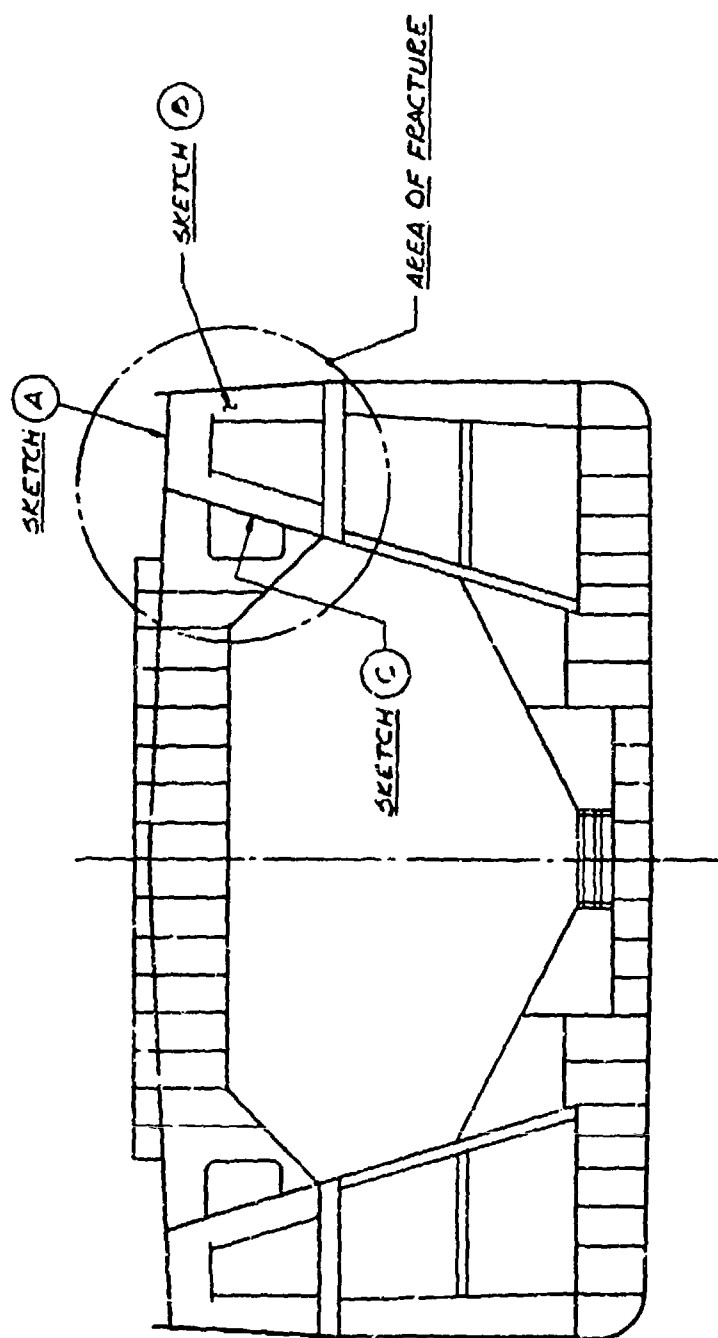
Figure 3-1 Midship section indicating the area of fracture
on the Great Lakes bulk carrier

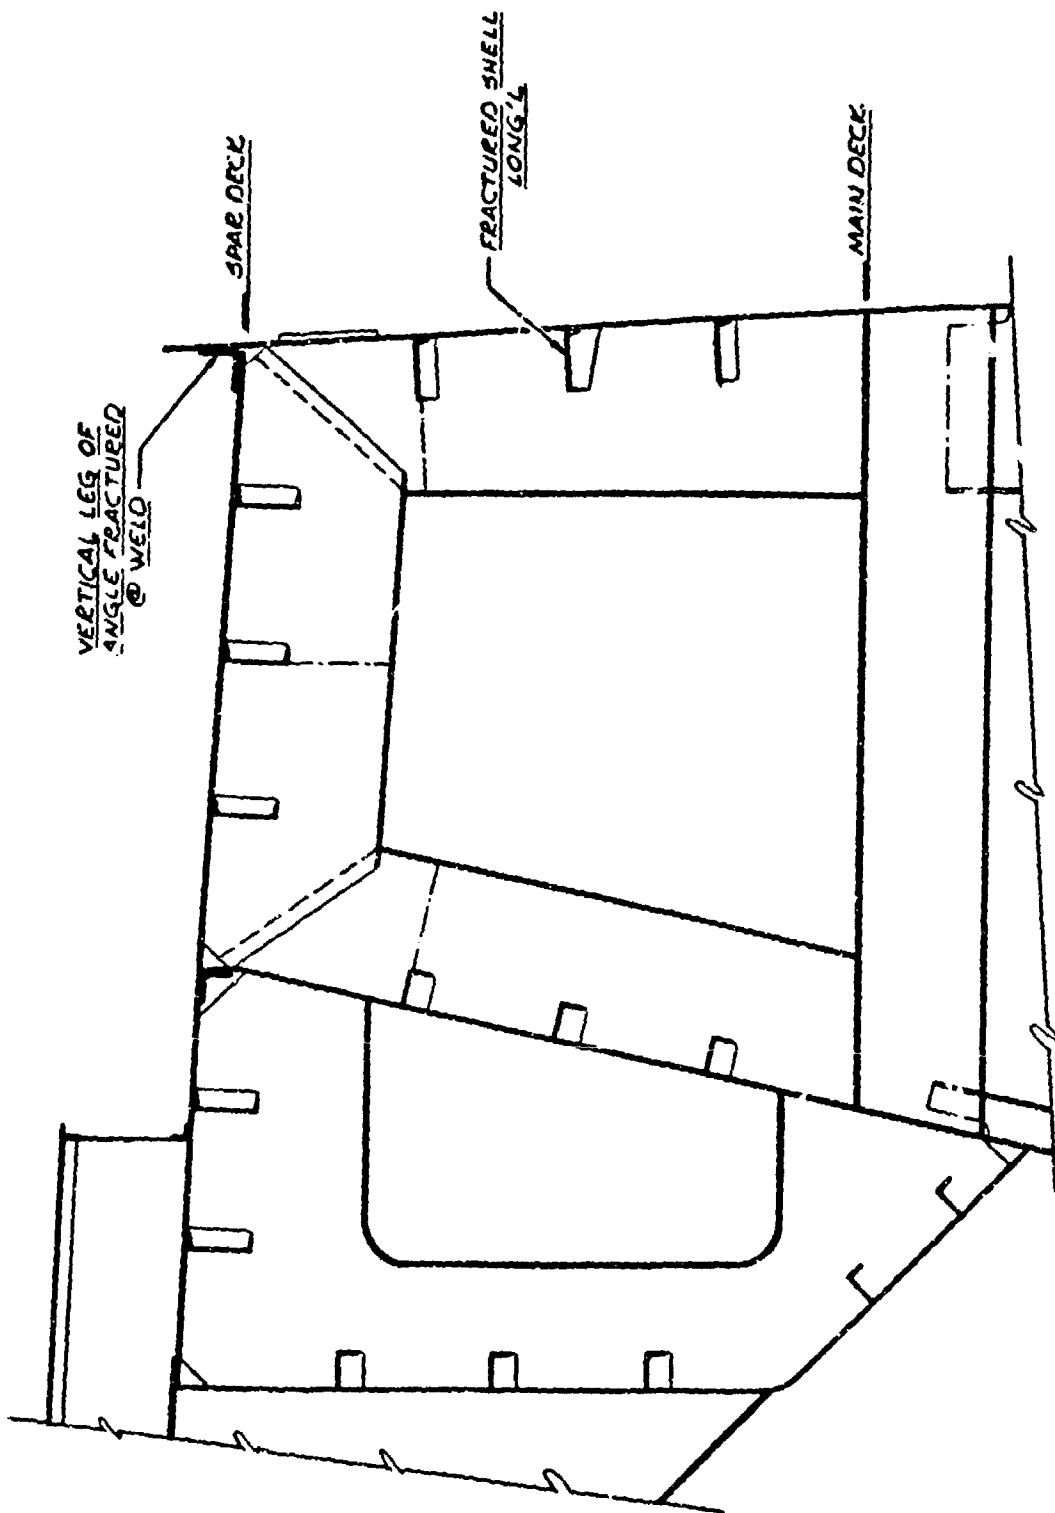
Figure 3-3 Section of the Upper Wing Tank of the Great Lakes Bulk Carrier

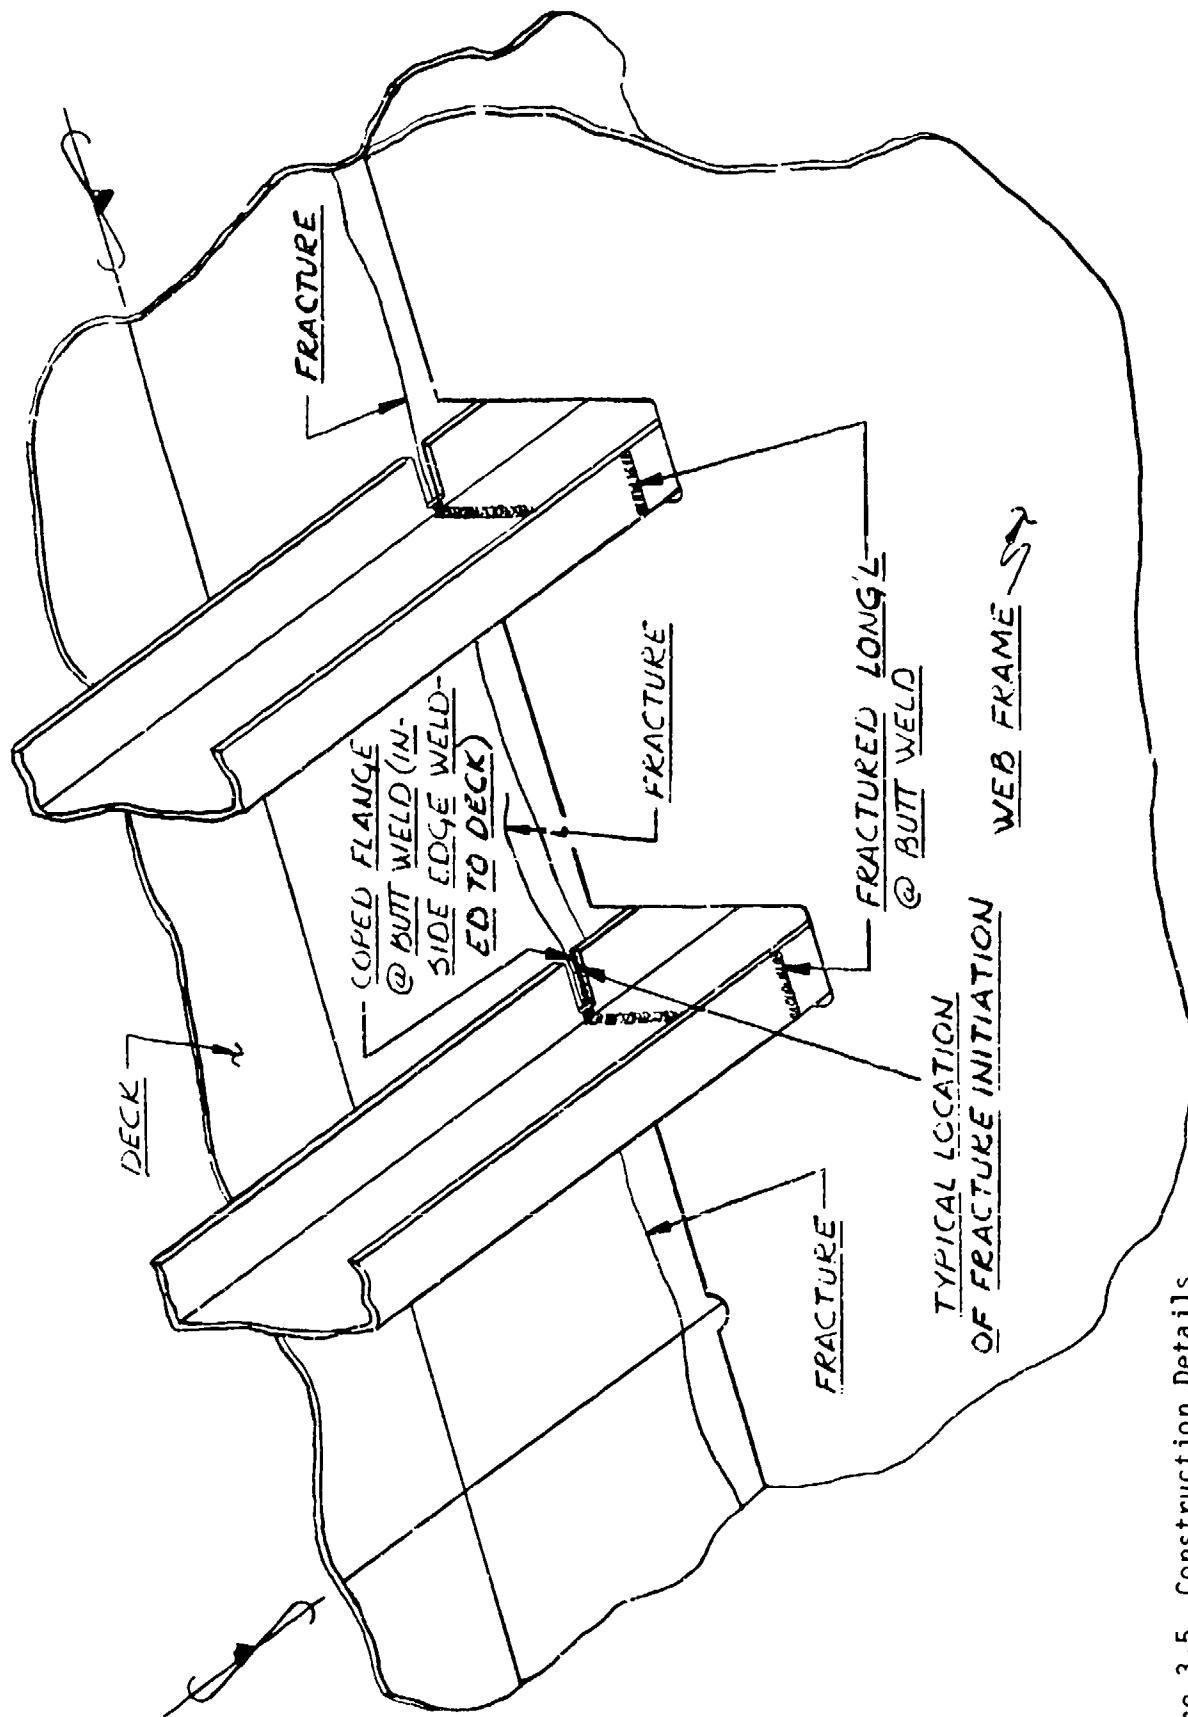
Figure 3-5 Construction Details associated with the Initiation of the Fracture on the Great Lakes Bulk Carrier

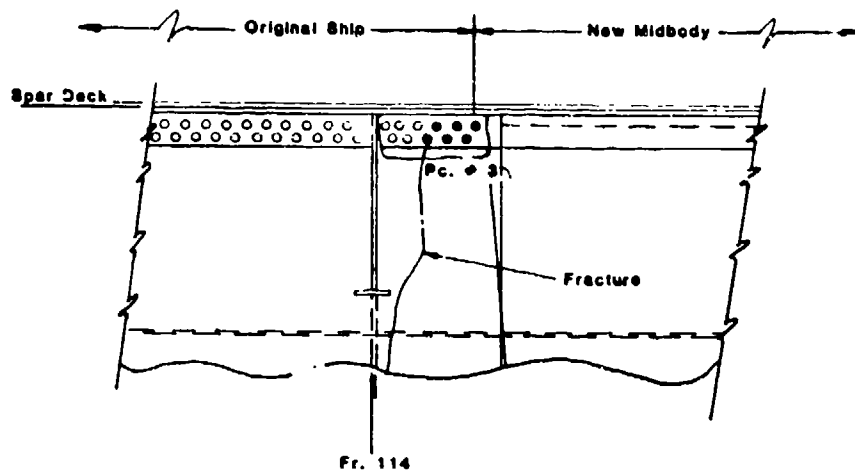
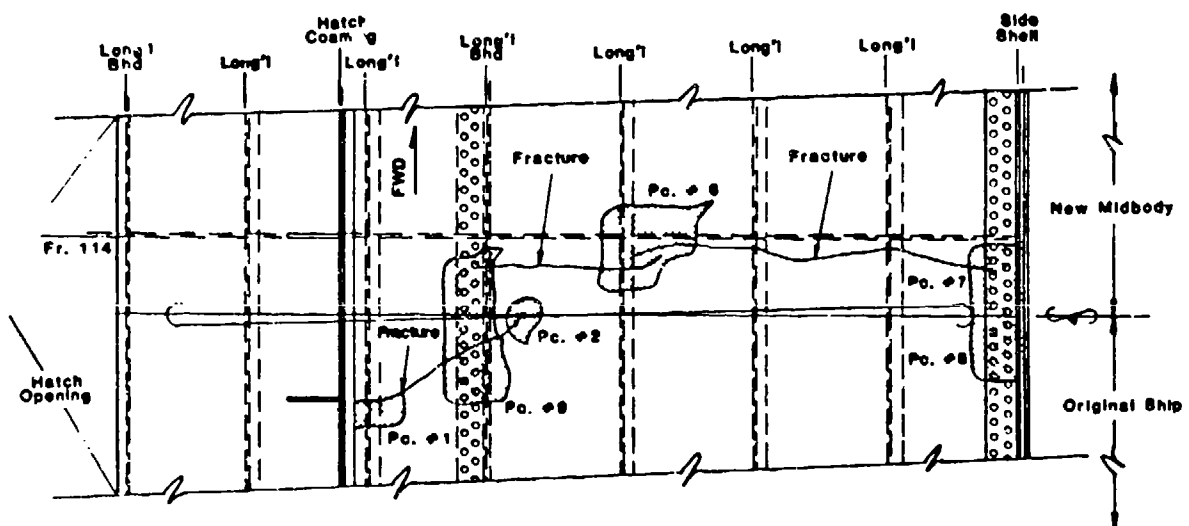
Nine samples were taken from the fractured plating and were shipped to Lehigh University for further examination of the fracture path, initiation sites, and arrest sites. The locations of these pieces in the spar deck are shown in Figure 3-6. A detailed description of the fracture samples is presented in [3-1]* and is summarized below.

Figure 3-6 Location of Plating Samples from the Great Lakes Bulk Carrier

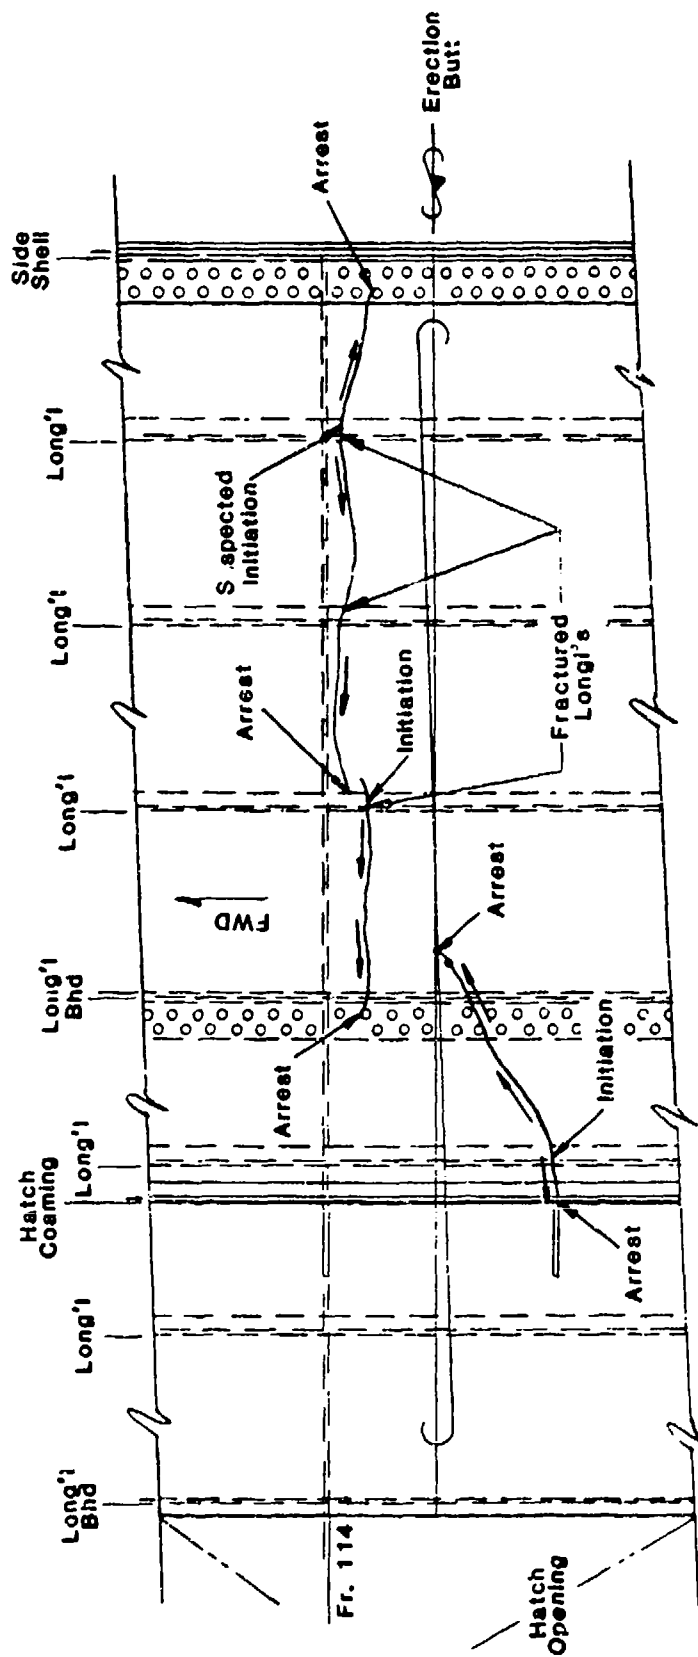
Based on the direction of chevron markers on the fracture surfaces, it can be concluded that the first fracture to form was that between samples No. 6 and 7. The crack between samples No. 6 and No. 9 formed next and then the one between samples No. 1 and 2. The bulkhead crack probably formed last. The path of fracture across the spar deck is as shown in Figure 3-14.

Figure 3-14 Plan of Spar Deck Fracture Initiation and Arrest Points

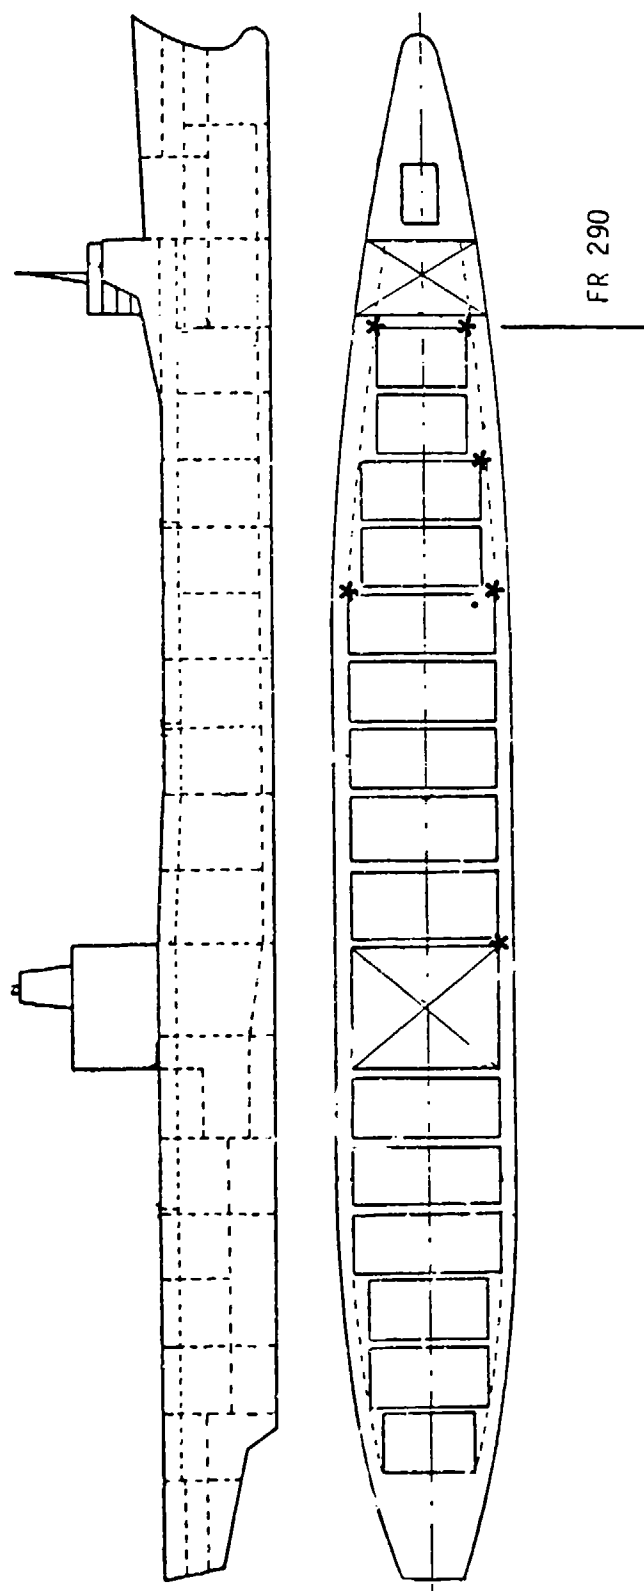
Figure 3-15 Elevation and deck lay out of the SL7 class of container ships showing frame locations of fractured hatch cut out where fatigue cracking occurred. Other locations where cracks were reported are indicated by *.

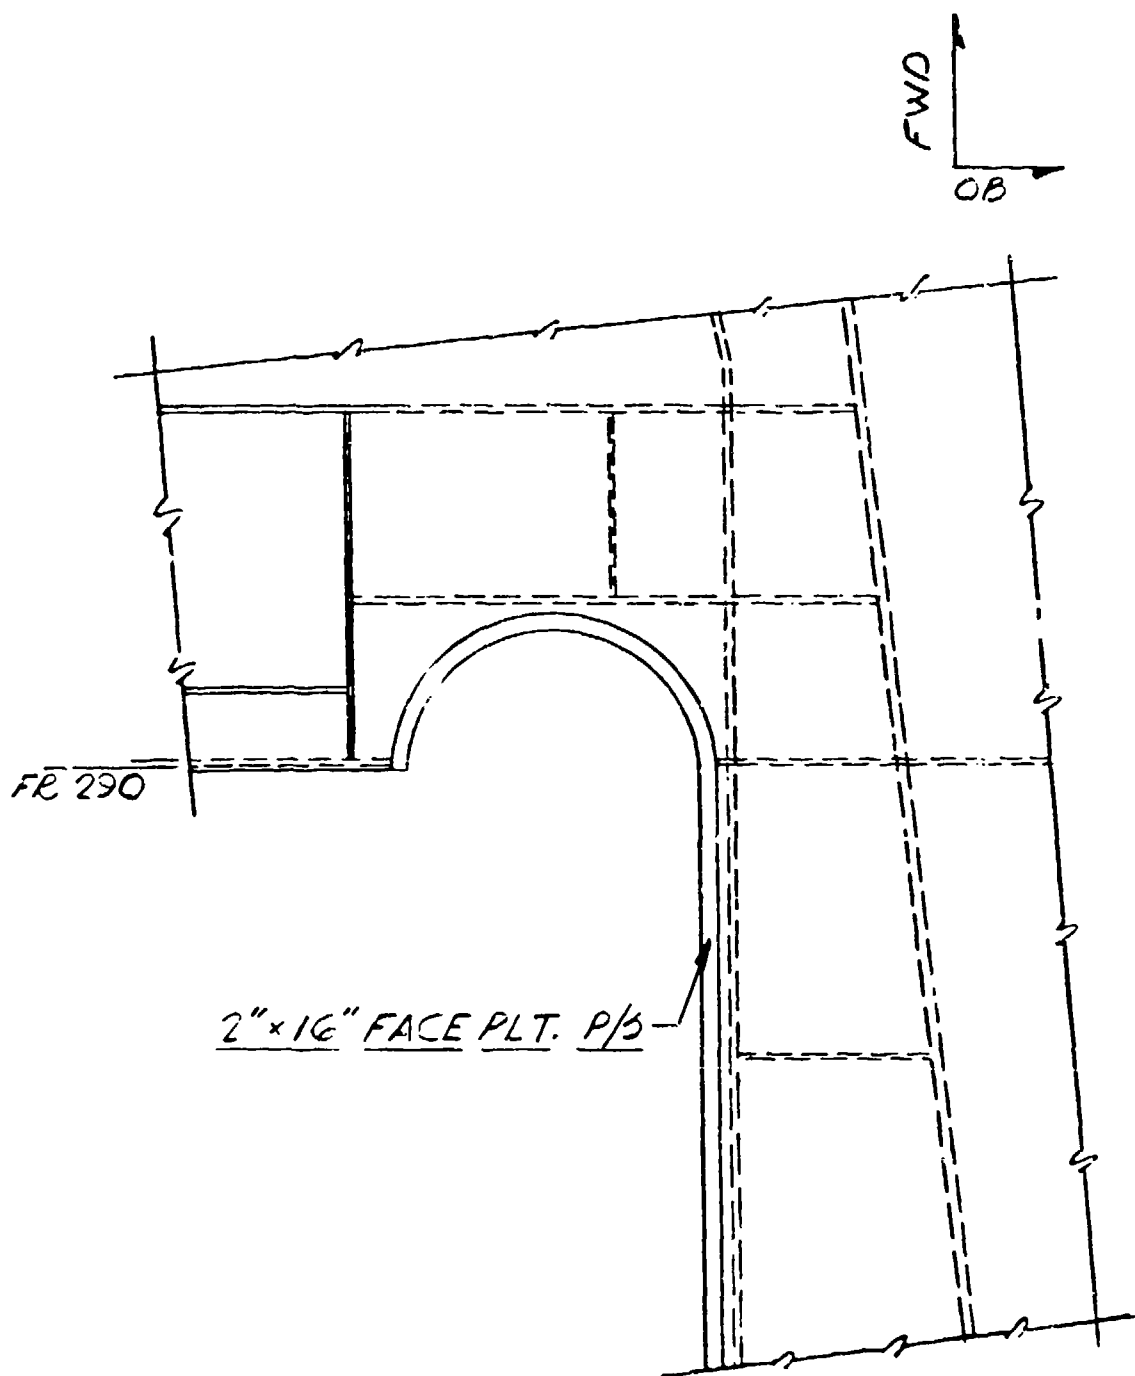
Figure 3-18 Face plate design for the forward hatch corner of the high speed containership

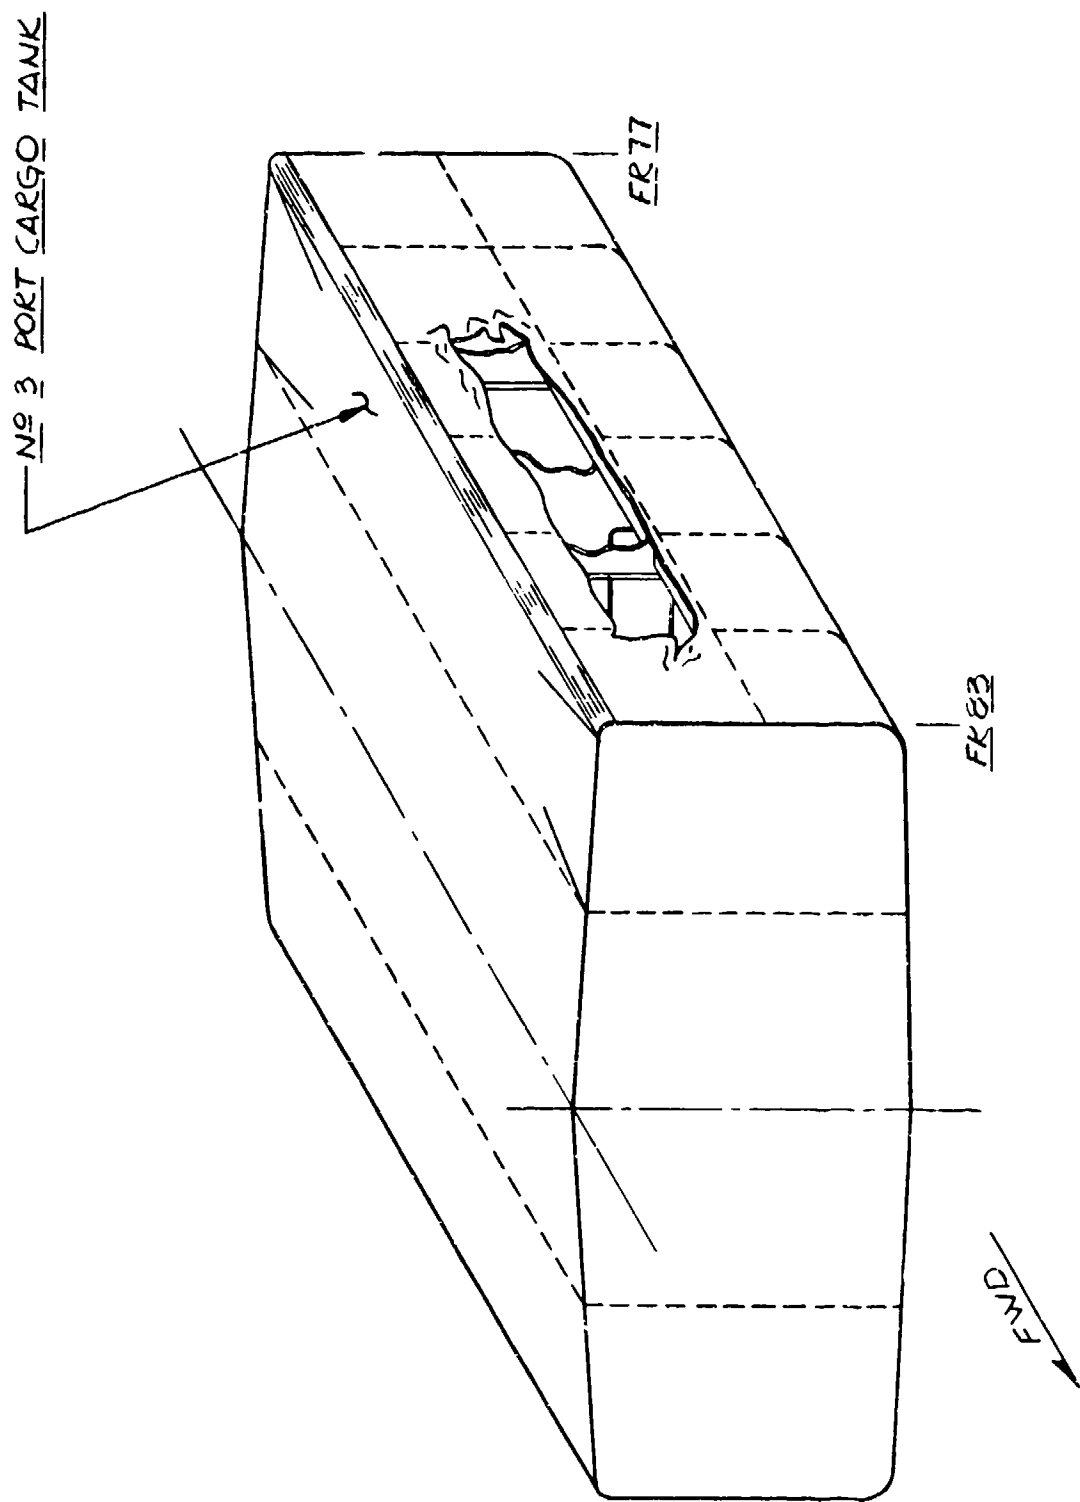
Figure 3-19 Cargo Hold Configuration of Tanker Showing Relative Location of Fracture

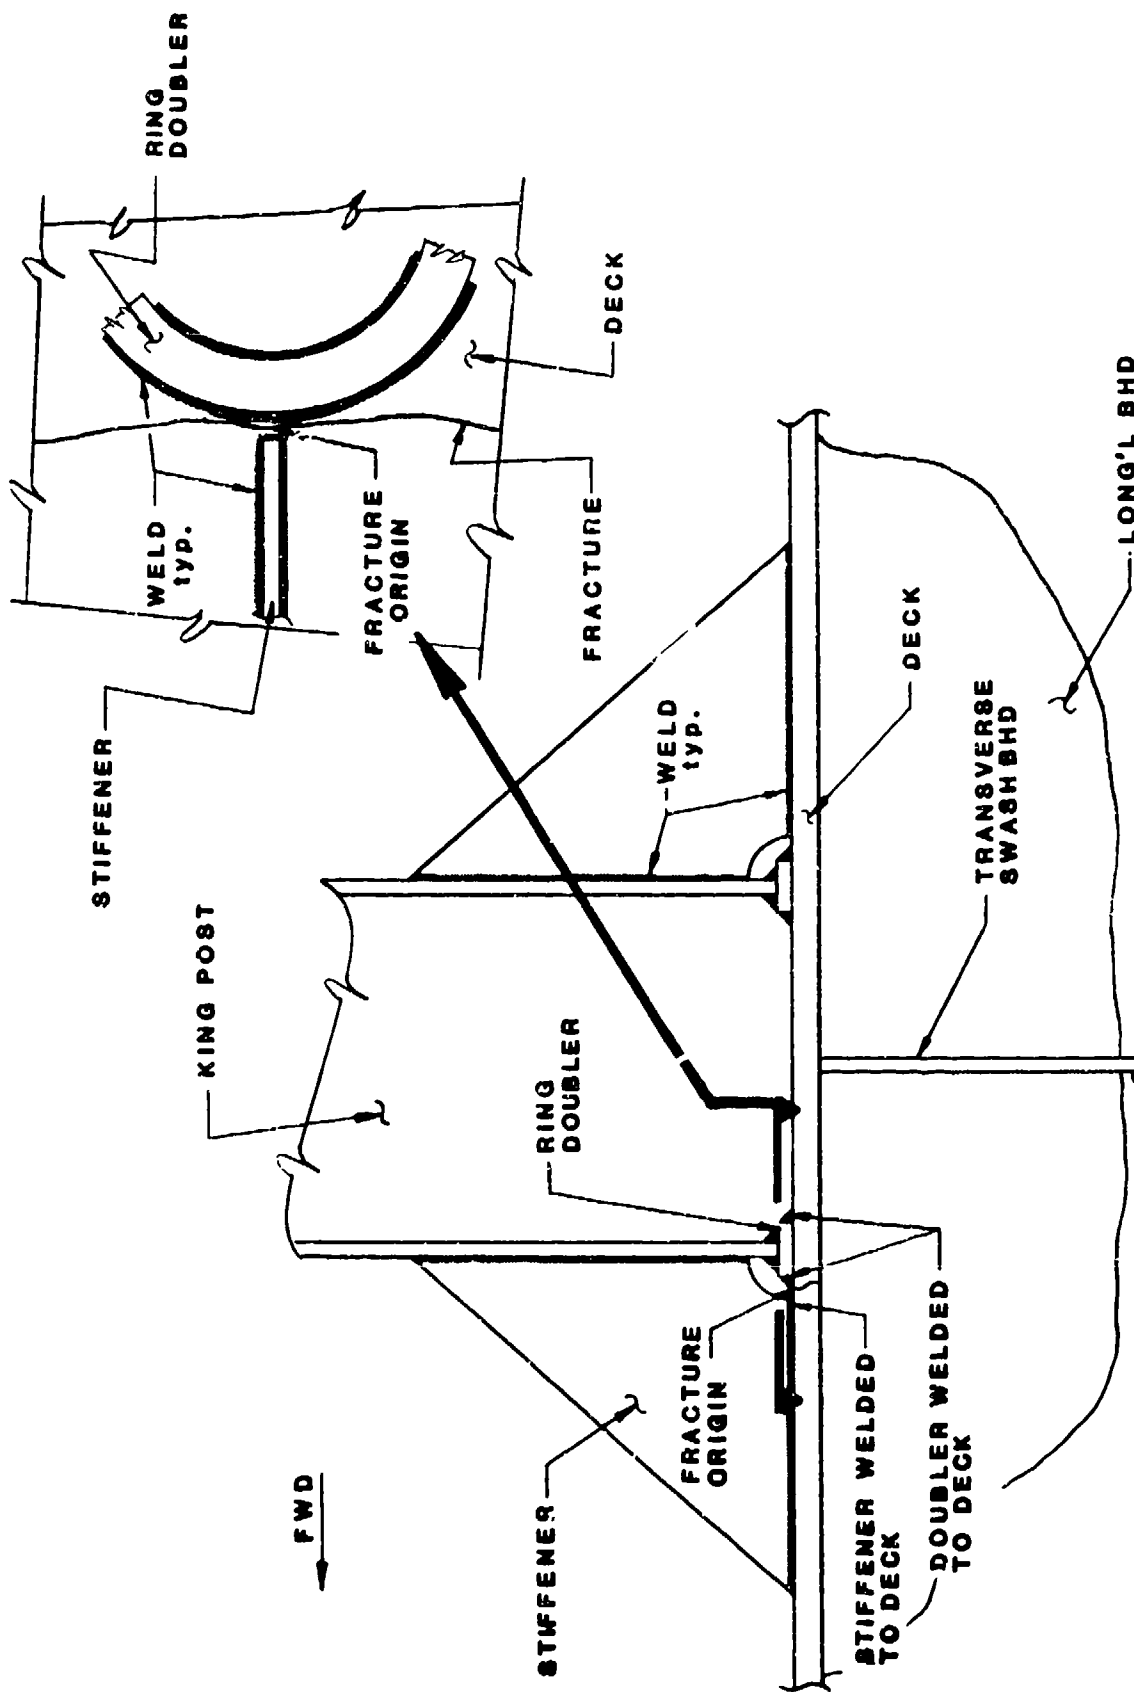
An unusual ballasting condition created a large stillwater bending moment with a resulting nominal stress of 23,515 psi in the deck, [3-4]. The combined effects of physical constraint, residual welding-induced stress and the nominal stress in the deck resulted in local stress sufficiently high to initiate a brittle fracture at the notch in the base of the king post.

Figure 3-22 Structural Detail at the Fracture Origin on the Tank Barge

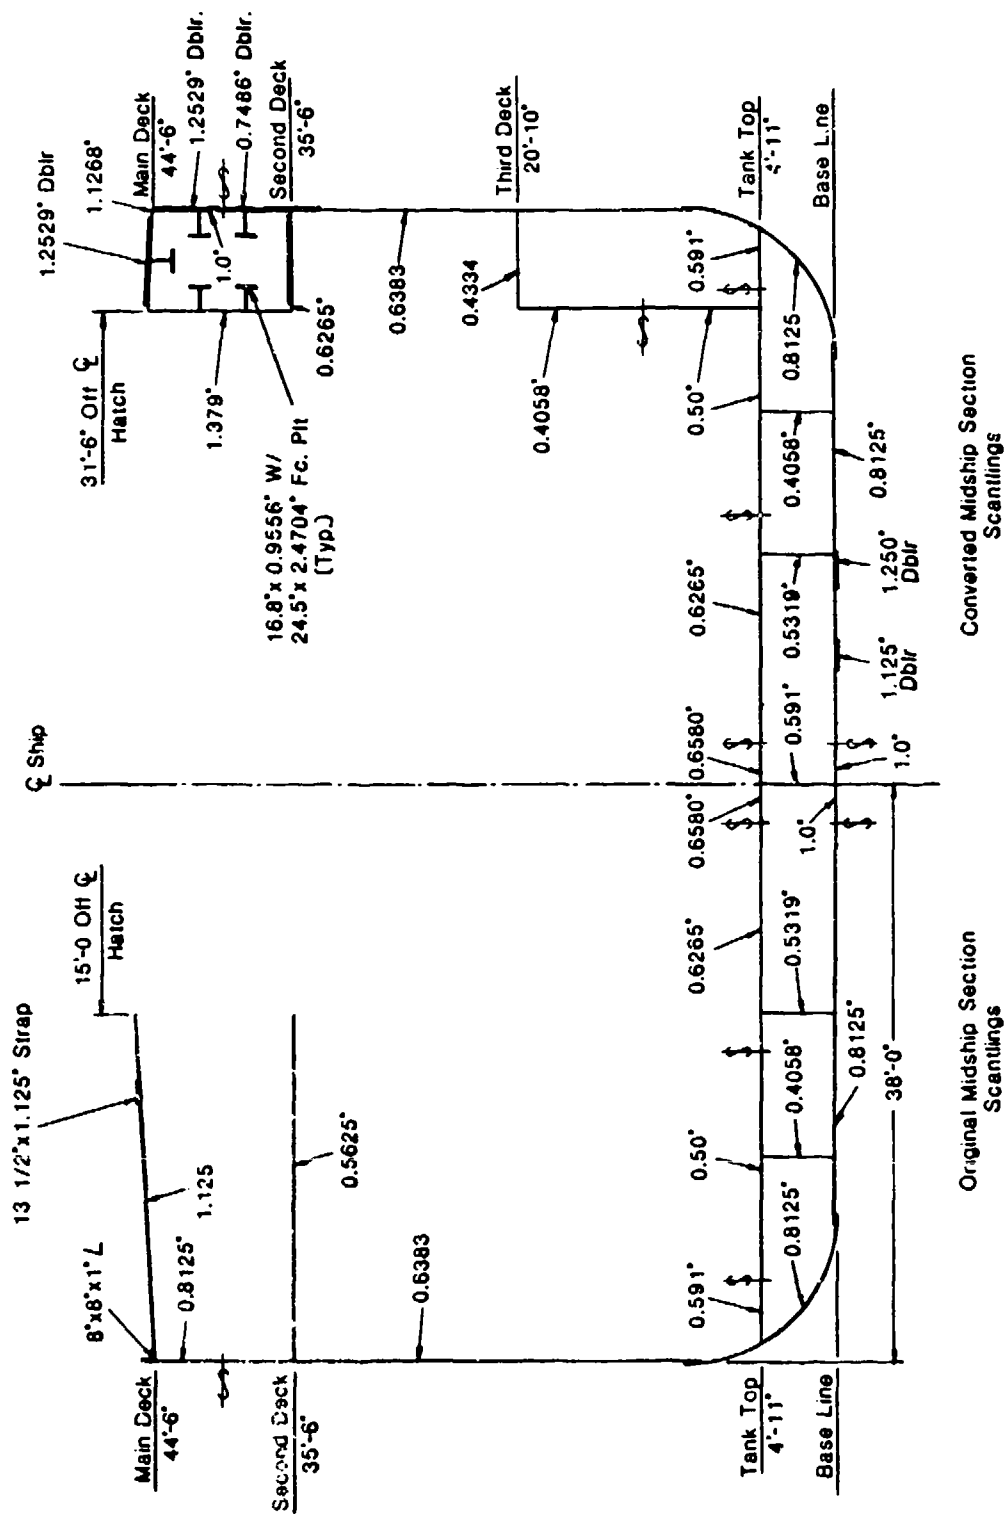
Figure 3-25 Midship Section of the Original Mariner Class and the Containership Conversion

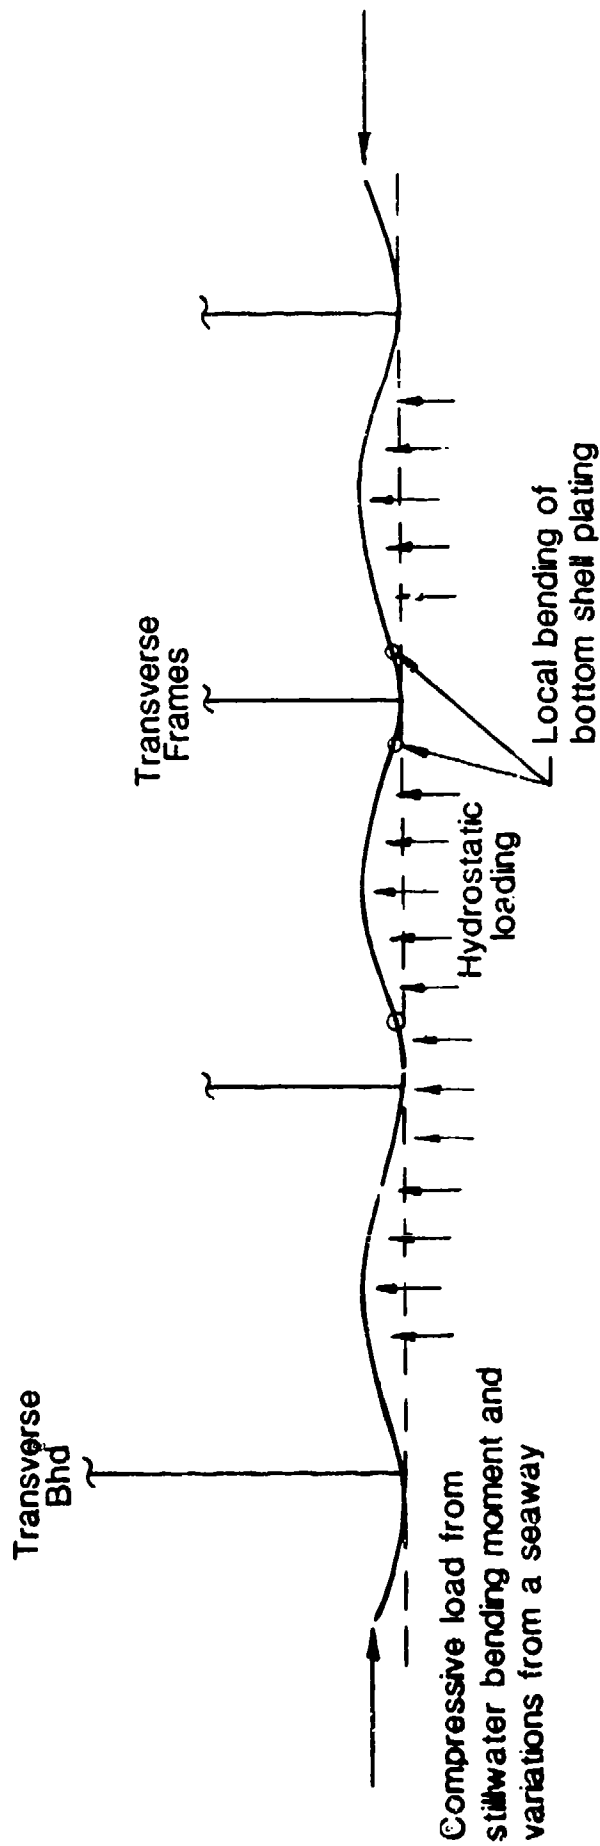
Figure 3-28 Illustration of Local Bending Associated With a Transversely Framed Ship

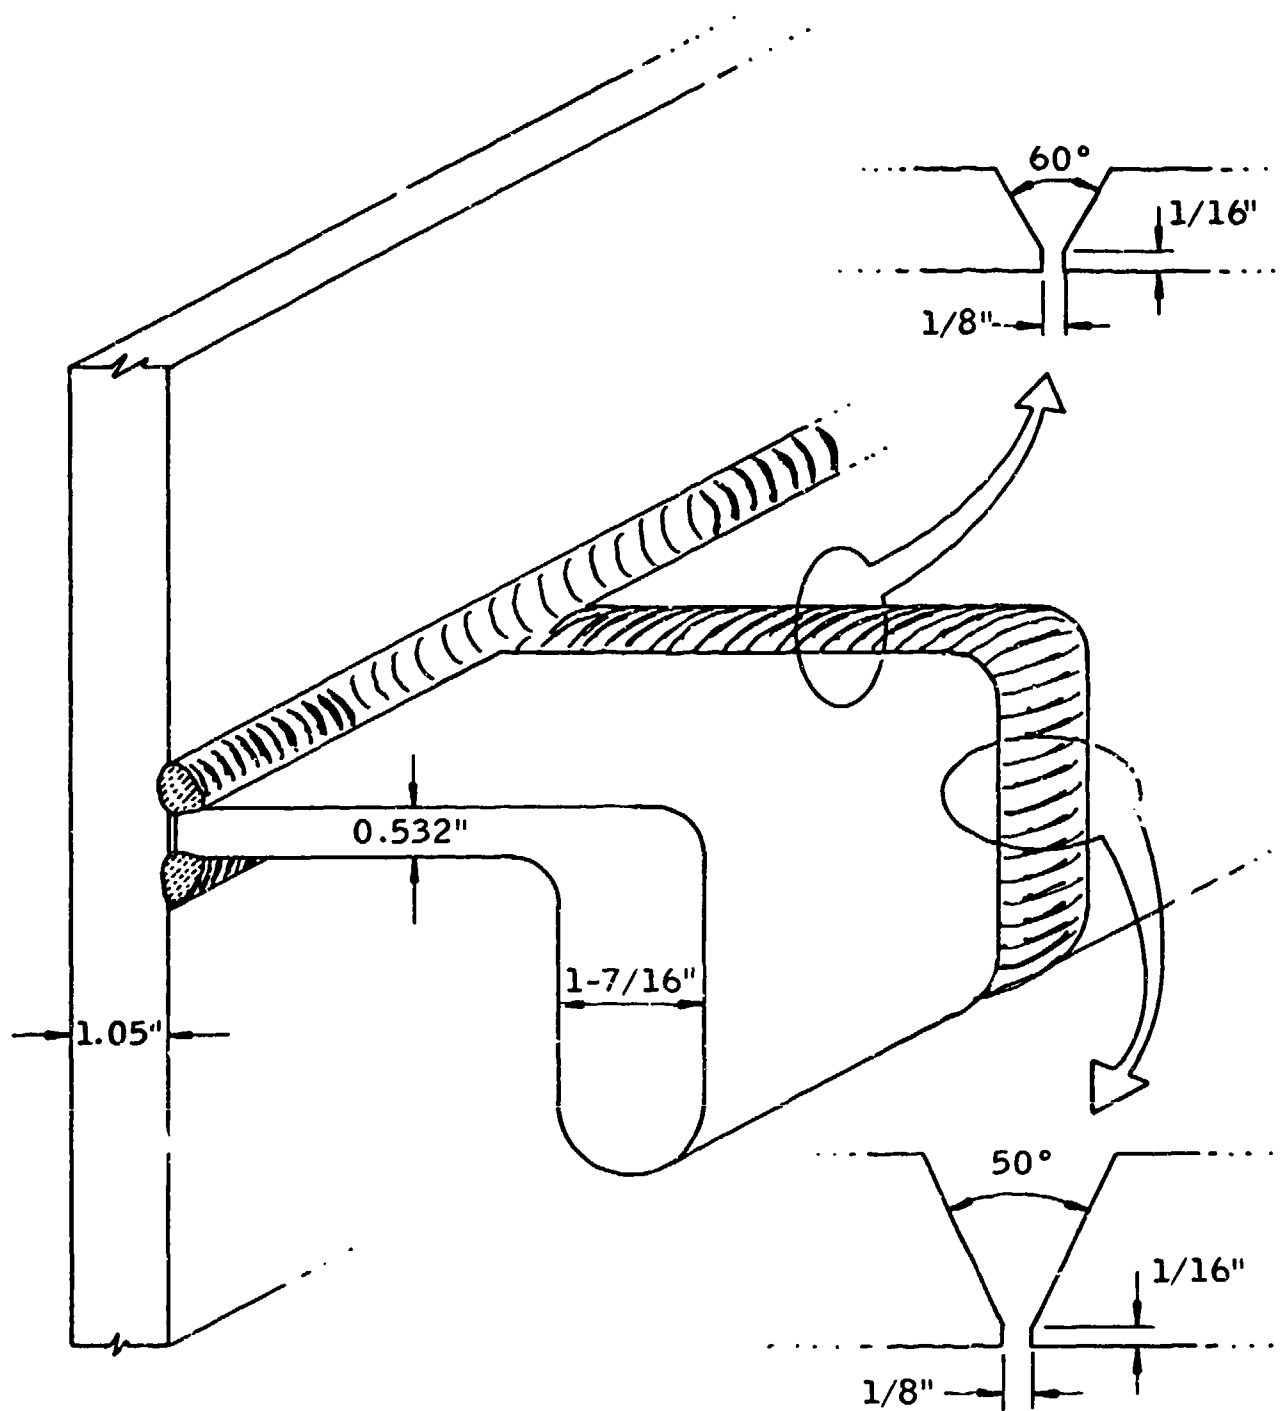
A detailed examination of the butt weld in No. 5 longitudinal showed that the weld was poorly made. Figure 3-40 is a sketch of how the weld attaching the longitudinals to the shell plate at the butt weld was supposed to be made. The butt welds in the web and face flange of longitudinal No. 5 are shown in Figure 3-41. The soundness of the web weld is good but it is obvious that the root was not back-chipped before back welding. The weld in the flange is extremely poor with effective fusion for less than half the depth. The lines "A", "B" and "C" indicate the angle of joint preparation. These welds obviously were not of the quality desired nor did they conform to the design joint of Figure 3-40.

Figure 3-40 Weld details as reported by the builder for butt and fillet welds on the longitudinals. Fillet weld is stopped short of butt. V'd side is welded complete, starting at shell plate and welding around to toe of flange. Opposite side is back-chipped and welded. Fillet weld to the shell is then completed.

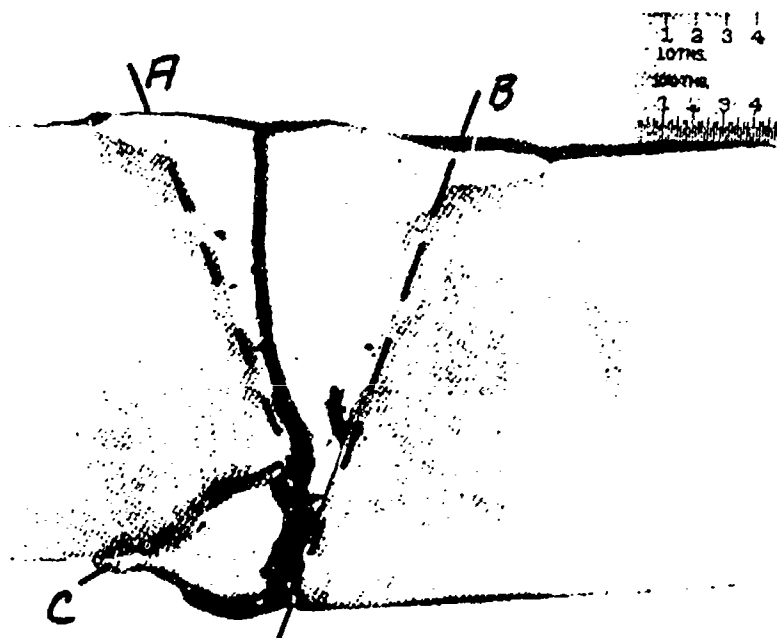
Figure 3-41 Cross sections through the butt welds in No. 5 longitudinal. Lines A, B and C indicate edge preparation prior to welding. The small beads were made from the underside or backside. Note wide cover pass. Specimen No. 3908; Etch, 4% Nital; Magn. 1.5x.

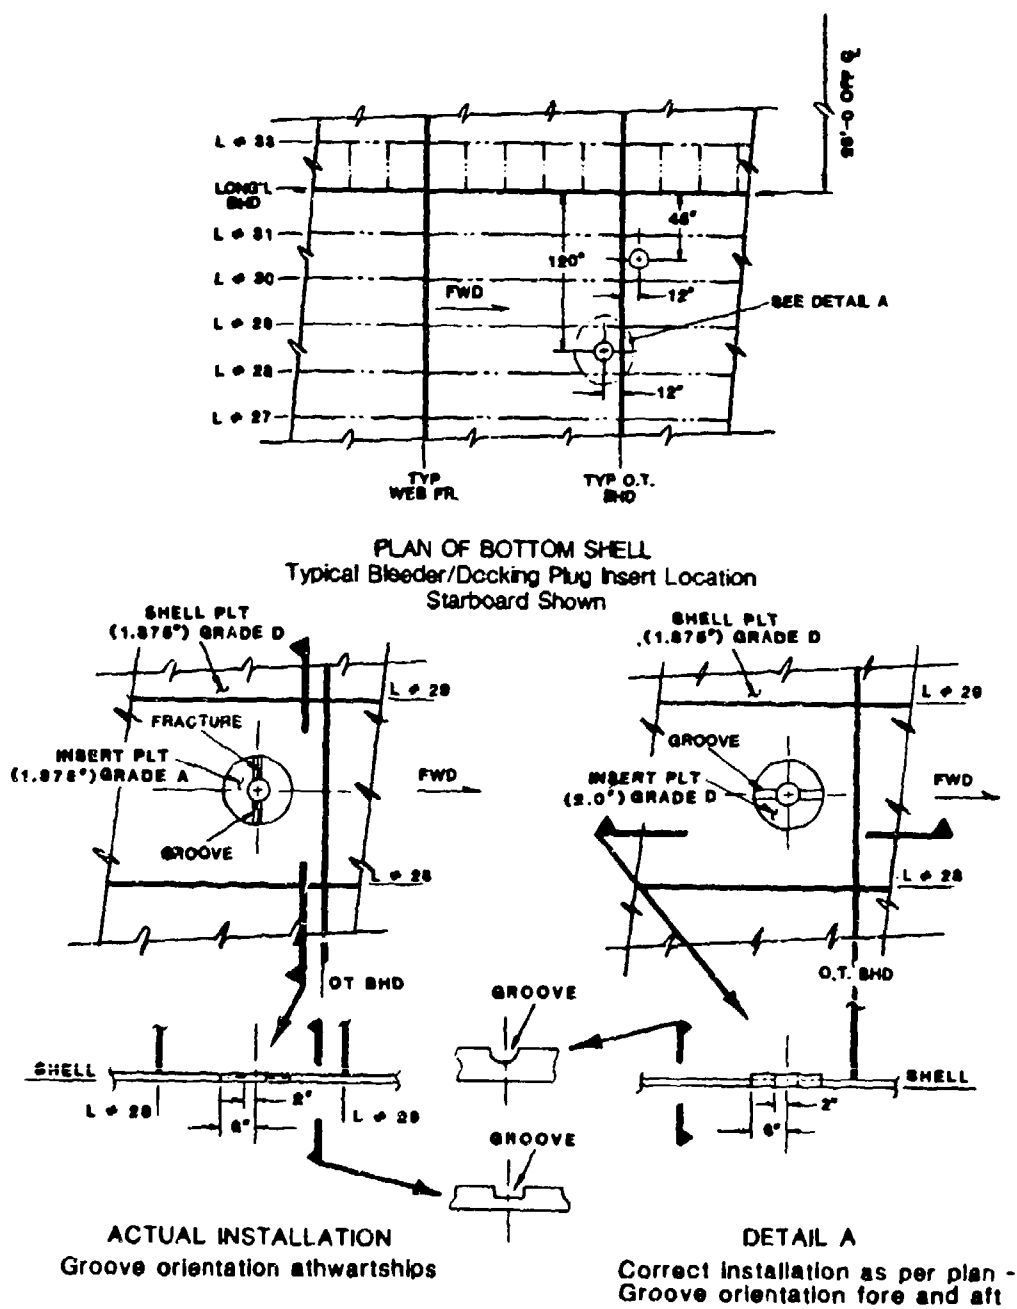
Figure 3-45 Structural Detail of the Docking Plug on the 70,000 DWT Tanker

plans for the new forebody note that the groove should run fore and aft. The grooves in the insert plates examined on the ship were installed athwartship as shown in Figure 3-45. This tanker had two plugs per tank, all of which had grooves running athwartship. In all, four insert plates were fractured at these grooves.

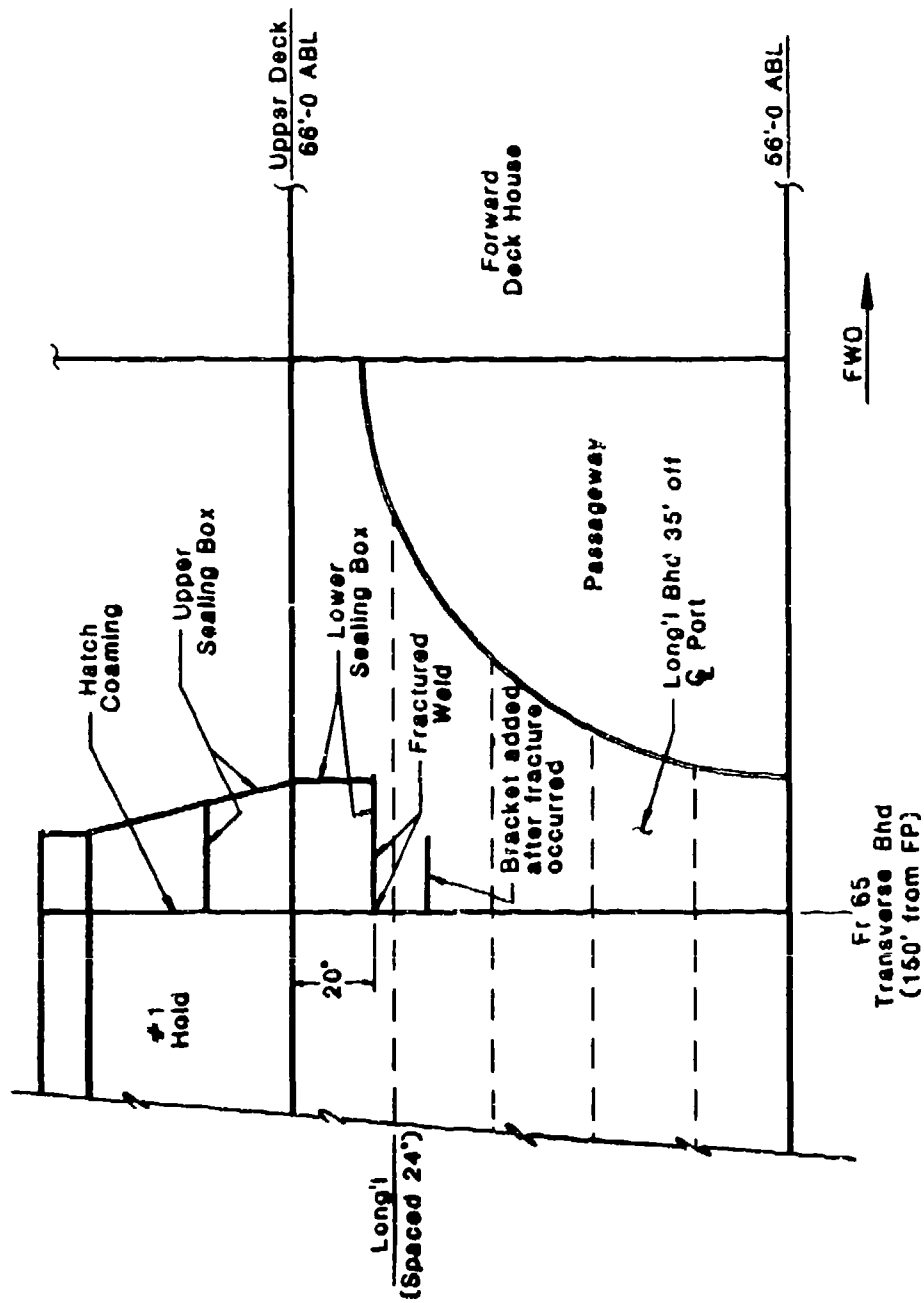
Figure 3-49 Longitudinal Bulkhead of the Containership With a Fractured Transverse Bulkhead

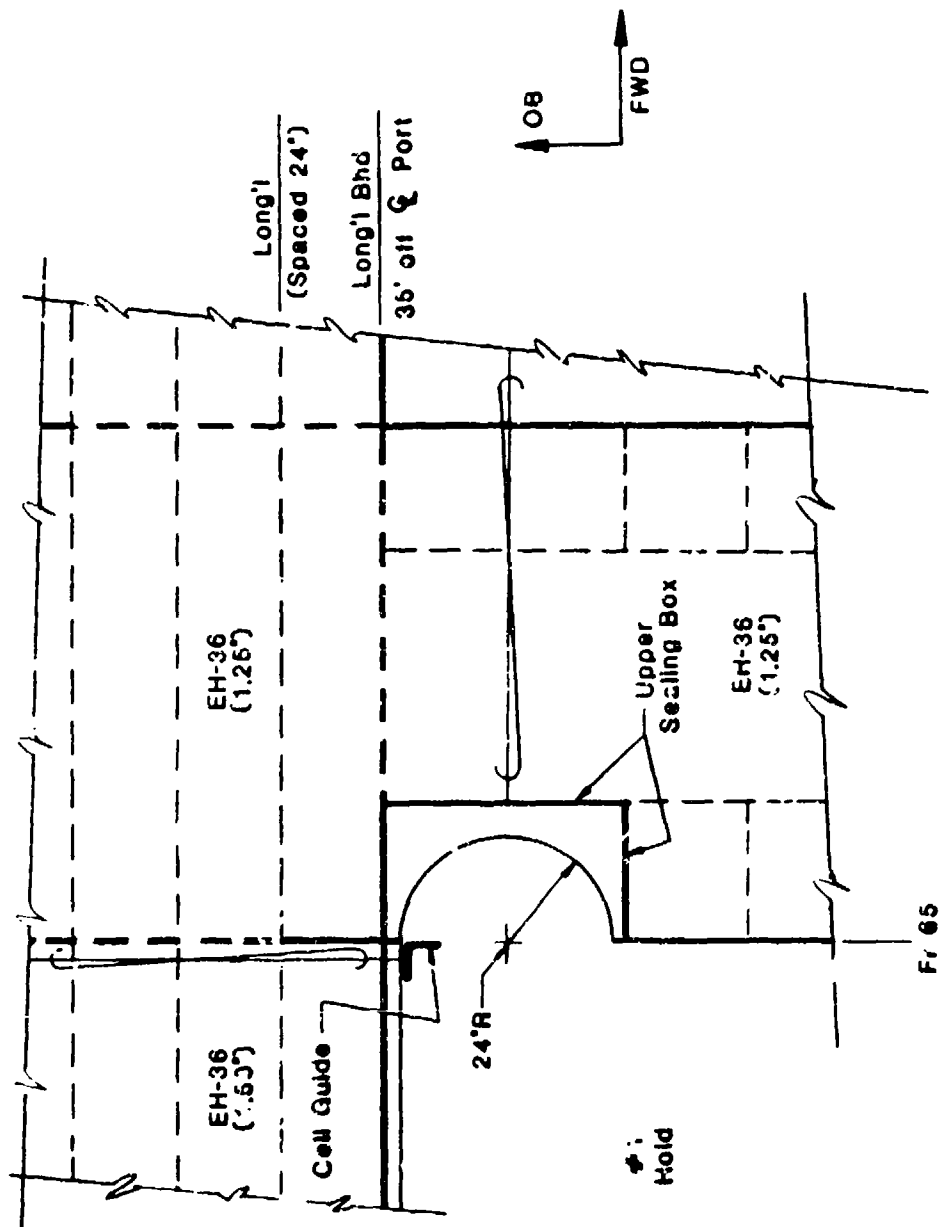
Figure 3-50 Hatch Cut-out of the Containership With a Fractured Transverse Bulkhead
